HOME INSPECTION REPORT

Inspection Address: 288 Sunrise Street

Inspector: Douglas Boykin

Inspection Date: 8/1/2024

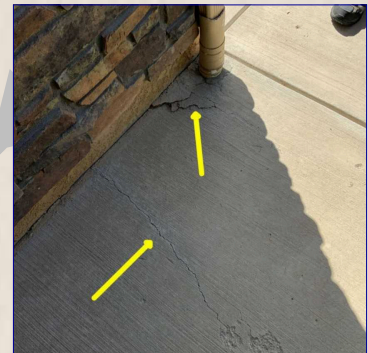
There is spalling on the service walks. Spalling is a common surface imperfection. Recommend a professional contractor repair to help prevent additional damage as needed.

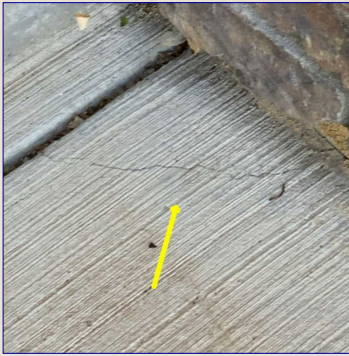
The walkway had some typical cracking/chipping but is usable. Recommend a professional contractor seal the cracks to help prevent additional damage.

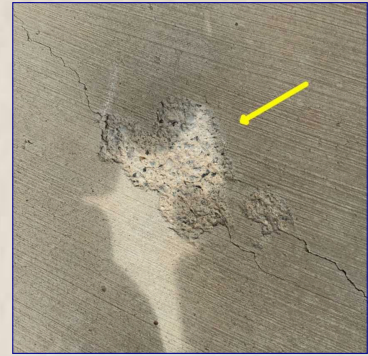
There is spalling on the service walks. Spalling is a common surface imperfection. Recommend a professional contractor repair to help prevent additional damage as needed.

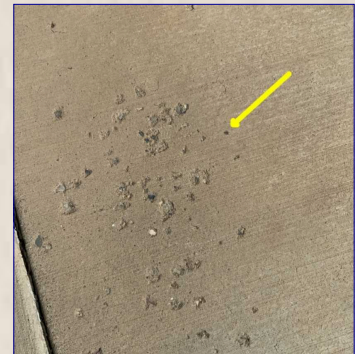
The driveway has areas of spalling. Spalling is a common surface imperfection. Recommend a professional contractor repair to help prevent additional damage.

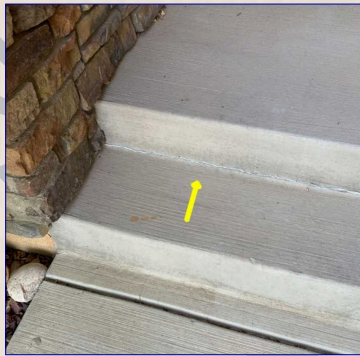
There is a crack at the steps.
Recommend a professional contractor
seal the crack to help prevent
additional damage to the concrete.

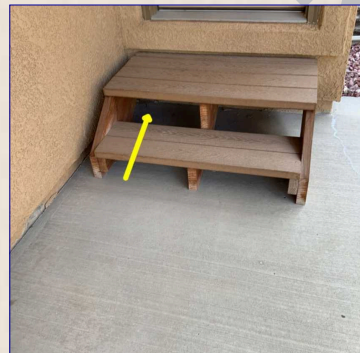
There are open risers on the exterior wood stairs, which is a potential safety concern. Recommend using additional caution in these areas. Install proper risers for added safety.

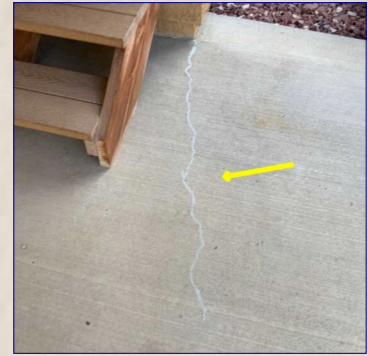
The patio has typical cracks. Recommend a professional contractor seal the cracks to help protect the cement from damage.

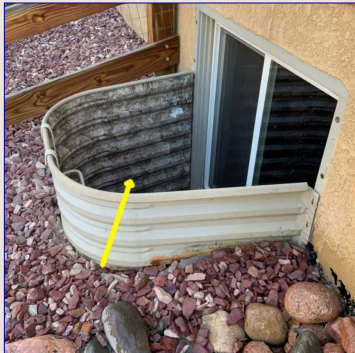
Window well covers are missing in one or more locations. Adding window well covers will help prevent moisture and debris from entering the window wells. In addition, an open window well is a falling hazard. Recommend adding window well covers.

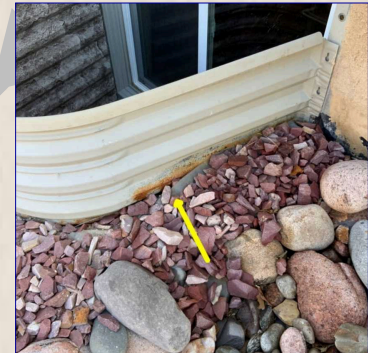
The window well had some rusting. Recommend monitoring and contacting a licensed contractor as needed.

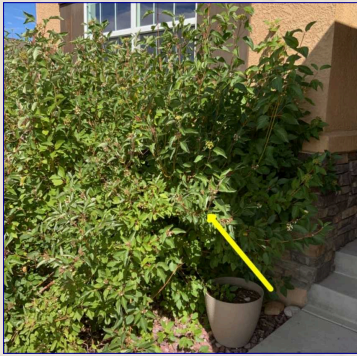
There is vegetation in contact with the house. Recommend trimming trees/vegetation, so it doesn't come into contact with the home.

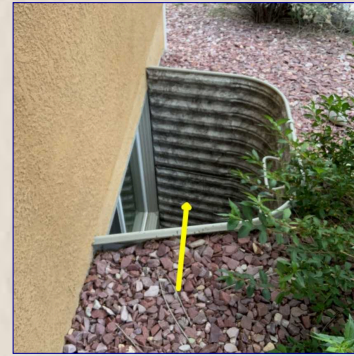
Window well covers are missing in one or more locations. Adding window well covers will help prevent moisture and debris from entering the window wells. In addition, an open window well is a falling hazard. Recommend adding window well covers.

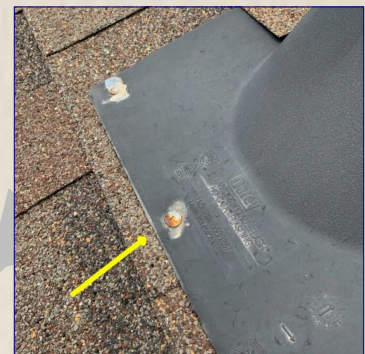
There are exposed nail heads securing the flashing to the roof. Exposed nail heads can allow water to penetrate the roof. Recommend a licensed roofer to seal the nail heads.

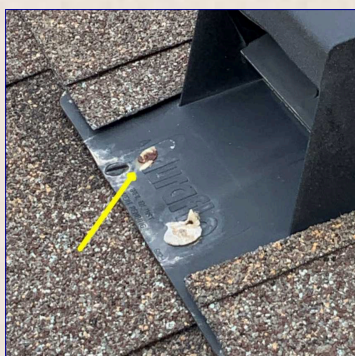
There are exposed nail heads securing the flashing to the roof. Exposed nail heads can allow water to penetrate the roof. Recommend a licensed roofer to seal the nail heads.

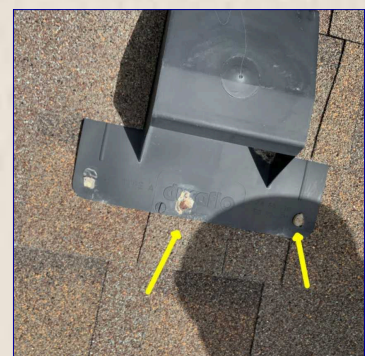
There are exposed nail heads securing the flashing to the roof. Exposed nail heads can allow water to penetrate the roof. Recommend a licensed roofer to seal the nail heads.

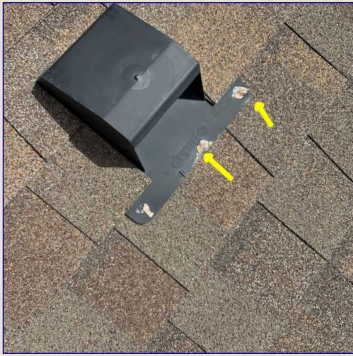
There are exposed nail heads securing the flashing to the roof. Exposed nail heads can allow water to penetrate the roof. Recommend a licensed roofer to seal the nail heads.

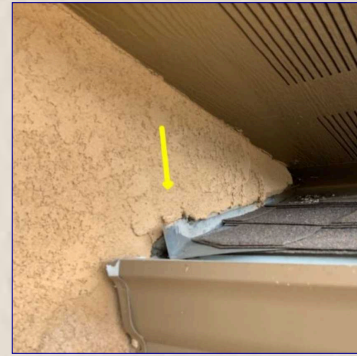
Kick Out flashing is missing at one or more locations, which may allow moisture damage on the home's exterior, walkways, and driveways. Recommend a licensed contractor install flashing to help properly move water to the gutter system. Repair damaged areas as needed.

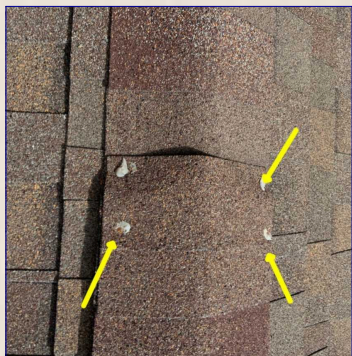
There are exposed nail heads on the roof. Exposed nail heads may allow water to seep through and damage the sheathing over time. Recommend a licensed roofer caulk the exposed nail heads.

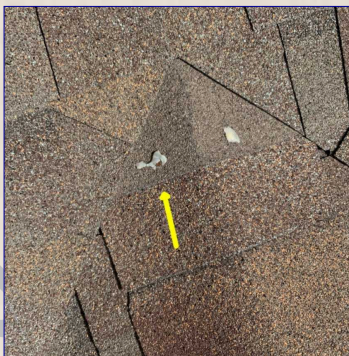
There are exposed nail heads on the roof. Exposed nail heads may allow water to seep through and damage the sheathing over time. Recommend a licensed roofer caulk the exposed nail heads.

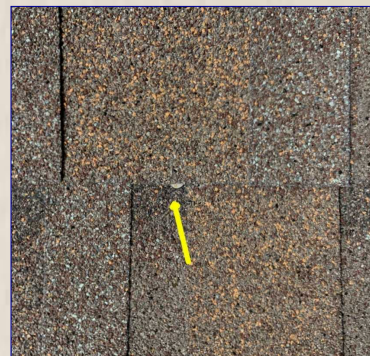
There are exposed nail heads on the roof. Exposed nail heads may allow water to seep through and damage the sheathing over time. Recommend a licensed roofer caulk the exposed nail heads.

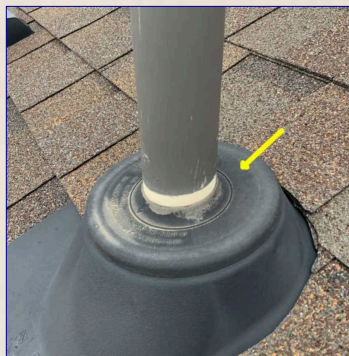
One or more plumbing vent flashing was sunken, which can allow water/ice build-up and cause premature failure and leaking of the plumbing vent. Recommend a professional roofing contractor repair or replace the roof pipe flashing.

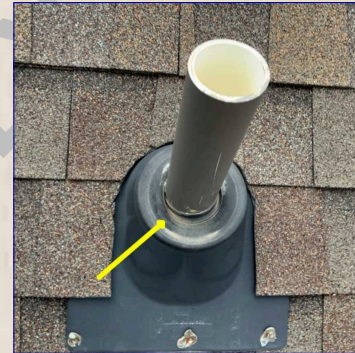
One or more plumbing vent flashing was sunken, which can allow water/ice build-up and cause premature failure and leaking of the plumbing vent. Recommend a professional roofing contractor repair or replace the roof pipe flashing.

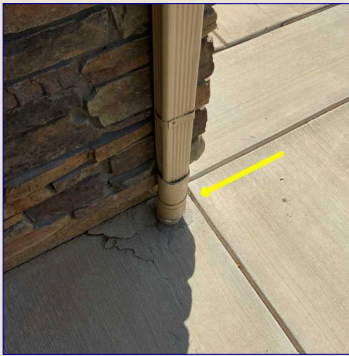
The gutter termination point was not visible. There is always the potential for hidden damage in non visible areas. Recommend monitoring and contacting a licensed contractor as needed.

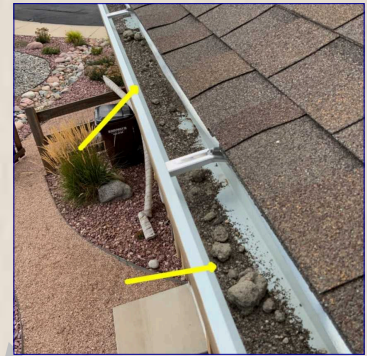
The gutters are dirty. Recommend cleaning the gutters to ensure proper water flow to the downspouts.

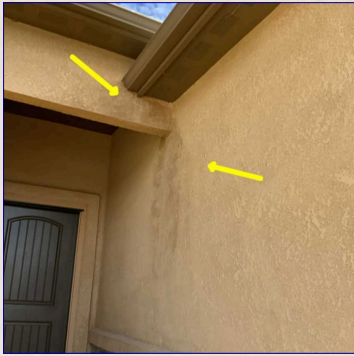
The stucco siding had moisture staining. Recommend licensed contractor evaluate and repair as needed.

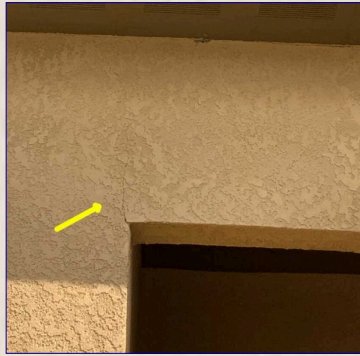
The stucco siding had typical cracking present in one or more areas. Monitor and repair as needed.

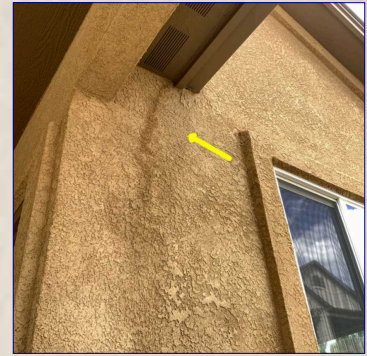
The stucco siding had moisture staining. Recommend licensed contractor evaluate and repair as needed.

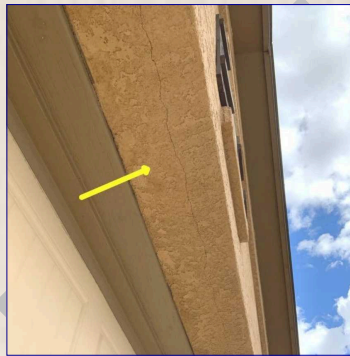
The stucco siding had typical cracking present in one or more areas. Monitor and repair as needed.

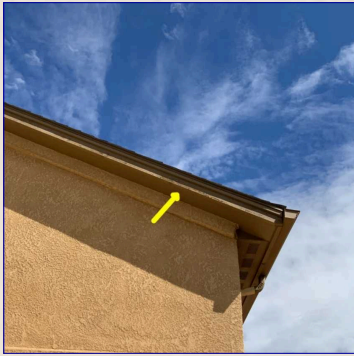
The fascia needs routine painting maintenance. Recommend a professional painter repair/paint the fascia.

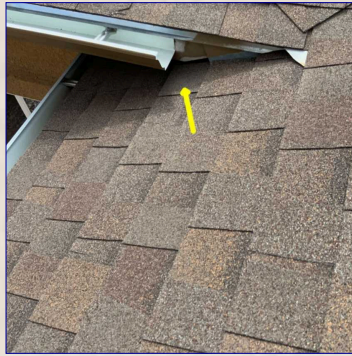
The fascia needs routine painting maintenance. Recommend a professional painter repair/paint the fascia.

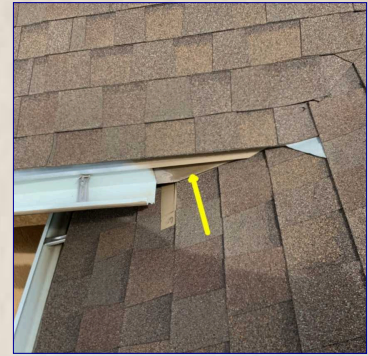
The fascia needs routine painting maintenance. Recommend a professional painter repair/paint the fascia.

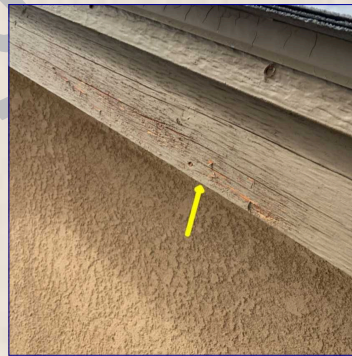
The fascia needs routine painting maintenance. Recommend a professional painter repair/paint the fascia.

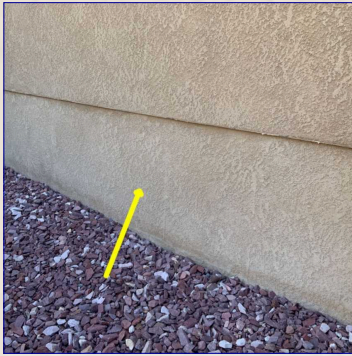
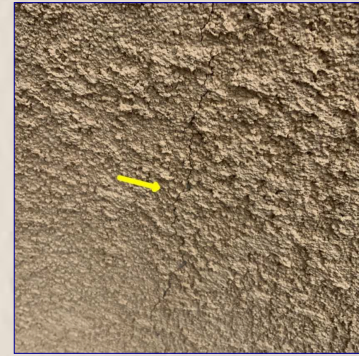
One or more areas of the foundation wall(s) have limited or no visibility. No evaluation can be made. Recommend monitoring and consulting a licensed contractor as needed.

There are expected vertical cracks in the foundation. All cracks have a potential for leaking and for future potential movement, which can not be predicted. Recommend sealing and monitoring. Consult a licensed foundation expert if any cracks start leaking or become active.

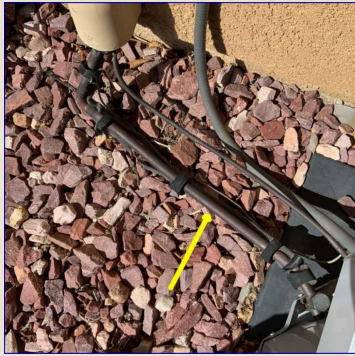
There is damaged and/or missing insulation on the air conditioner refrigerant line. Recommend replacing insulation.

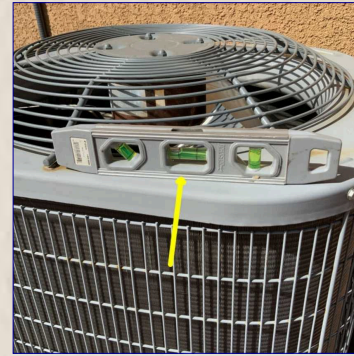
The air conditioner condensing unit is not level. Recommend a licensed HVAC contractor, evaluate and re-level the unit. Make any necessary repairs needed.

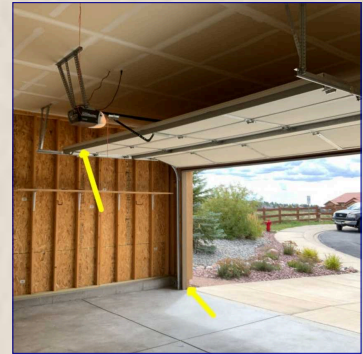
The safety devices on the large garage door cannot be tested due to the door not operating properly. Recommend a licensed contractor repair and re-test safety features on garage door.

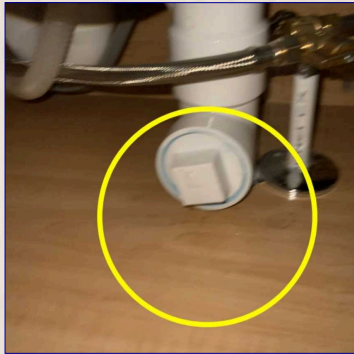
Drains in the kitchen are leaking, recommend a licensed plumber repair.

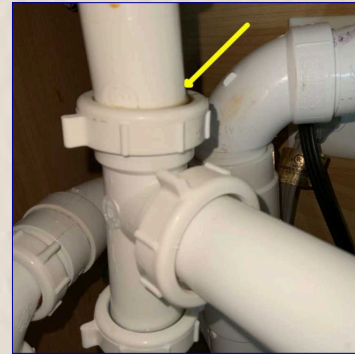
Drains in the kitchen are leaking, recommend a licensed plumber repair.

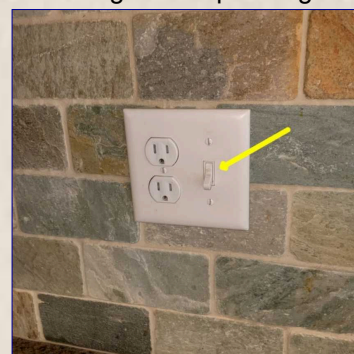
The switch did not appear to operate a fixture. Recommend contacting current owners as to purpose of switch. Contact a licensed electrician as needed.

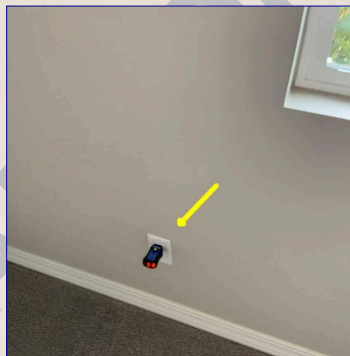
There are loose receptacles present in the room, which is a potential safety concern. Recommend a licensed electrician repair.

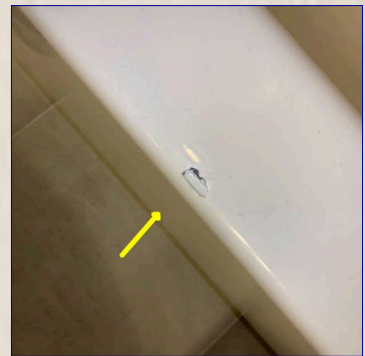
There are chips in the bathtub. Recommend sealing the chips tho help prevent additional damage.

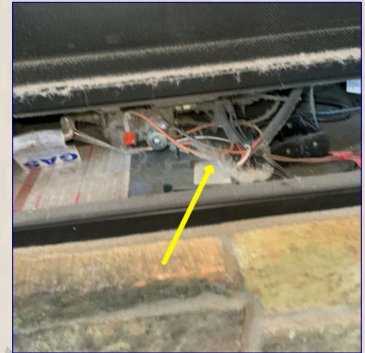
The fireplace compartment was dirty. Recommend cleaning compartment.

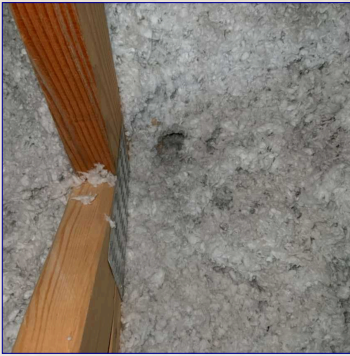
Pests are not part of the home inspection. However, there is evidence of rodent feces in the attic, which is a safety concern. Recommend a professional exterminator be consulted.

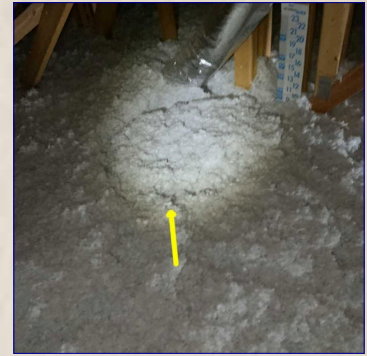
Pests are not part of the home inspection. However, there is evidence of rodent feces in the attic, which is a safety concern. Recommend a professional exterminator be consulted.

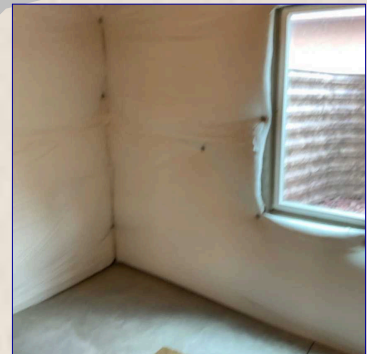
Foundation walls were covered with paneling/drywall/insulation/storage and were not visible. It is always possible that hidden damage may exist in non-visible areas. Consult a licensed contractor as needed.

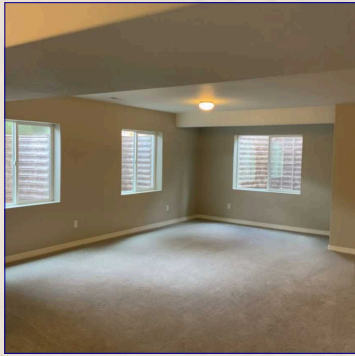
Foundation walls were covered with storage material and were not visible. It is always possible that hidden damage may exist in non-visible areas. Consult a licensed contractor as needed.

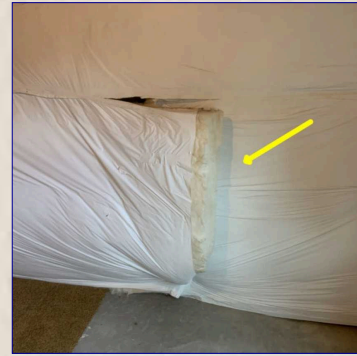
The insulation was displaced. Recommend repair as needed.

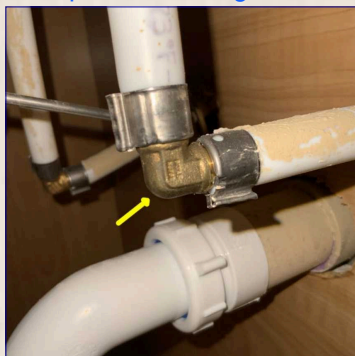
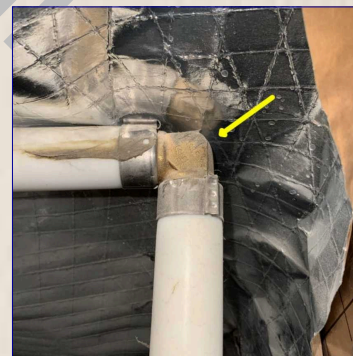
Brass fittings were noticed in the PEX house plumbing supply that appears to be manufactured by Zurn or other manufacturers. These fittings have been known to fail and have been part of a class action lawsuit. The yellow brass fittings can be located at joints in a plastic pipe. Brass fittings are secured in the pipe with copper crimp rings or stainless steel clamps. The fittings were used for various applications, including and without limitation, hot and cold water distribution in plumbing and radiant heating systems present in homes, residences, buildings, or other structures. As part of making an investment decision in this house, we recommend a licensed plumber, familiar with the fittings, referred to in the class action lawsuit(s) evaluate and repair, or replace the fittings as needed.

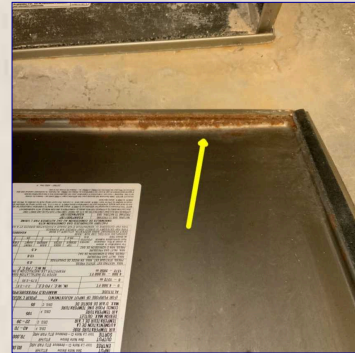
The furnace showed signs of rust and corrosion. Recommend a professional HVAC technician repair or replace as needed.
