HOME INSPECTION REPORT

Inspection Address: 288 Sunrise Street

Inspector: Douglas Boykin

Inspection Date: 8/1/2024

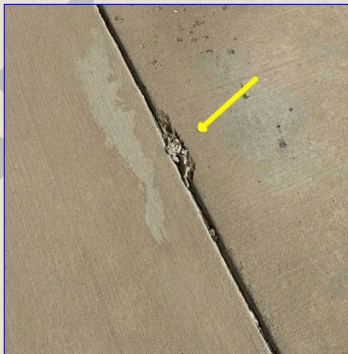
The driveway has areas of spalling. Spalling is a common surface imperfection. Recommend a professional contractor repair to help prevent additional damage.

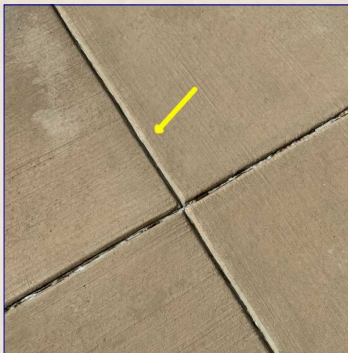
The driveway is cracked. Recommend sealing the cracks to help prevent additional damage. Consult a professional contractor as needed.

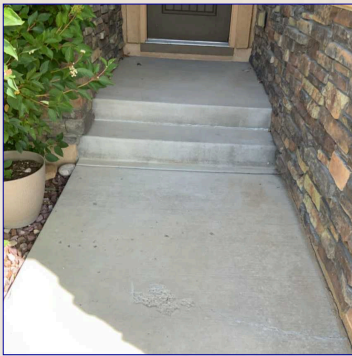
The Steps/Stoop View

There is a crack at the steps.
Recommend a professional contractor
seal the crack to help prevent
additional damage to the concrete.

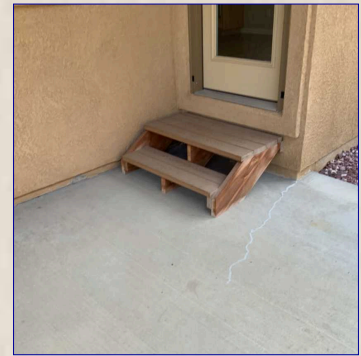
The Steps/Stoop View

There are open risers on the exterior wood stairs, which is a potential safety concern. Recommend using additional caution in these areas. Install proper risers for added safety.

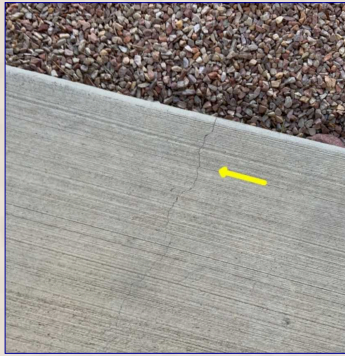
The patio has typical cracks. Recommend a professional contractor seal the cracks to help protect the cement from damage.

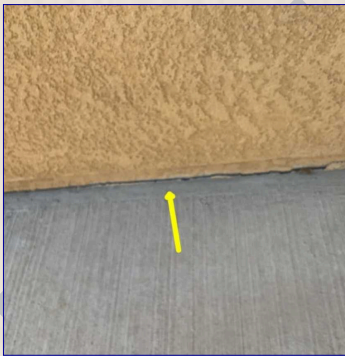
There is a gap between the patio and the house. Recommend sealing the gap between the patio and the house to help prevent water penetration.

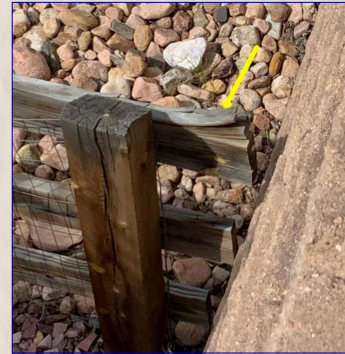
The fence has some damage. Recommend consulting with a professional contractor for regular maintenance repairs.

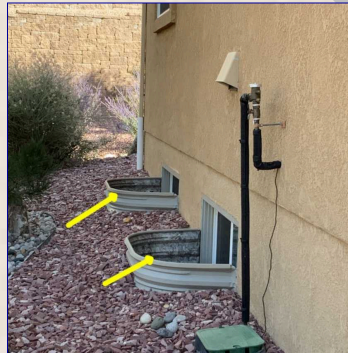
Window well covers are missing in one or more locations. Adding window well covers will help prevent moisture and debris from entering the window wells. In addition, an open window well is a falling hazard. Recommend adding window well covers.

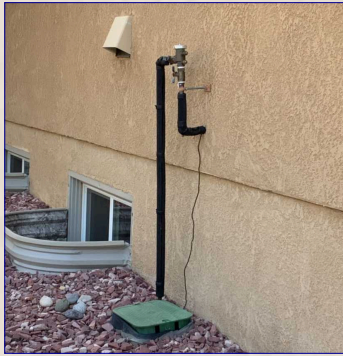
The lawn sprinkler system is not within the scope of the home inspection. Lawn sprinkler professionals recommend having the system serviced near the end of October and the end of May, depending on the local weather, for a seasonal shut down and start up. Recommend an irrigation landscape company service as needed.

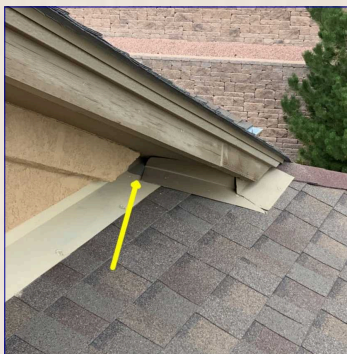
There were gaps at the flashing.
Recommend a licensed roofer evaluate repair as needed.

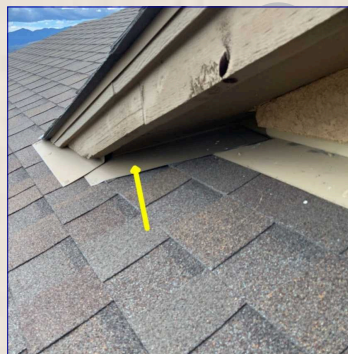
There were gaps at the flashing.
Recommend a licensed roofer evaluate repair as needed.

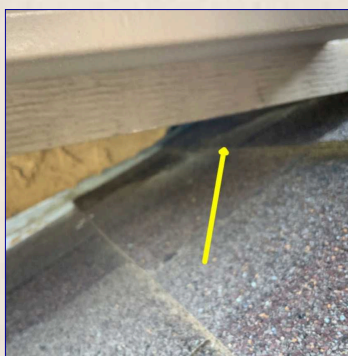
There were areas of missing flashing.
Recommend licensed roofer install flashing.

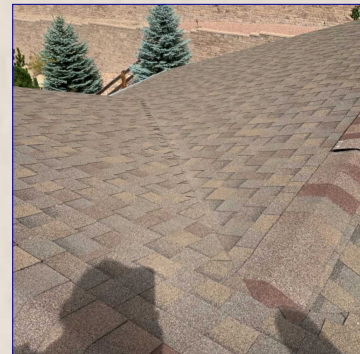
The Valley

The roof **valley** inspection is limited to the visual portion of the valleys. There is always the potential for hidden damage in non visible areas. Recommend monitoring and consulting a licensed roofer as needed.

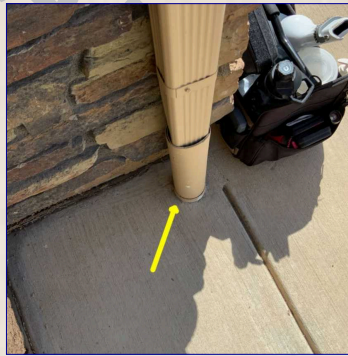
The gutter termination point was not visible. There is always the potential for hidden damage in non visible areas. Recommend monitoring and contacting a licensed contractor as needed.

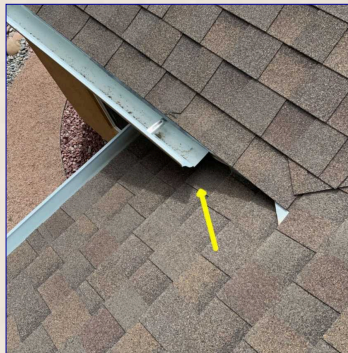
Gutters terminate on roof surfaces, which is a common practice but will concentrate a large amount of water on one location of asphalt shingles. This will allow more wear in one location. Recommend redirecting the water discharge to other gutters or to the ground.

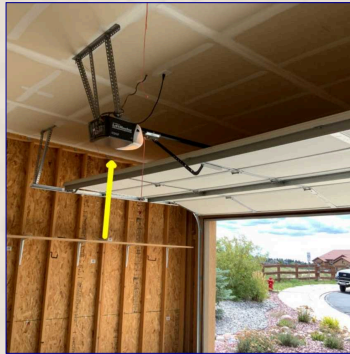
The automatic garage door opener was not working properly. Recommend a professional contractor evaluate and repair or replace as needed.

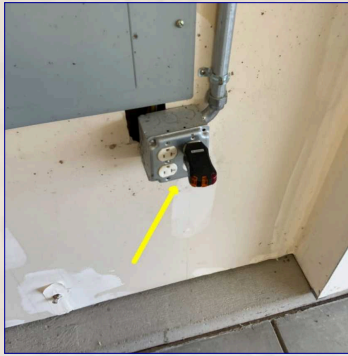
Not all of the electrical outlets are GFCI's installed in the garage, which is a safety concern. Recommend a licensed electrician install GFCI receptacles.

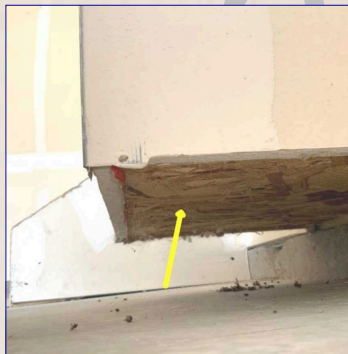
The firewall between the garage and living area is not present in spots - Potential Safety Hazard. Recommend a licensed contractor install a firewall.

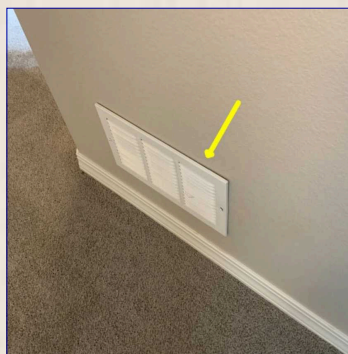
The heating vent has become damaged/detached from the floor or ceiling. Recommend a professional contractor repair as needed.

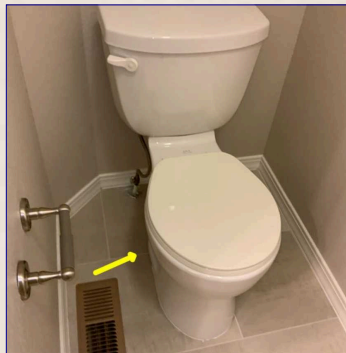
- The toilet bowl is loose. Since movement of the toilet will damage the wax ring, recommend replacing the wax ring. While the toilet is removed verify the flange, piping and sub floor is still in good condition. Repair as needed.

The toilet bowl is loose. Since movement of the toilet will damage the wax ring, recommend replacing the wax ring. While the toilet is removed verify the flange, piping and sub floor is still in good condition. Repair as needed.

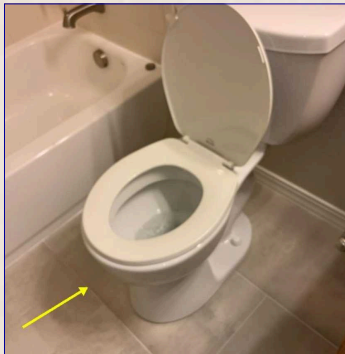
- The toilet bowl is loose. Since movement of the toilet will damage the wax ring, recommend replacing the wax ring. While the toilet is removed verify the flange, piping and sub floor is still in good condition. Repair as needed.

The toilet bowl is loose. Since movement of the toilet will damage the wax ring, recommend replacing the wax ring. While the toilet is removed verify the flange, piping and sub floor is still in good condition. Repair as needed.

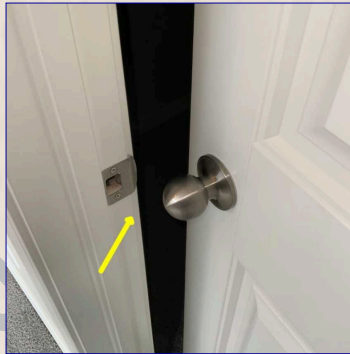
The door does not latch. Recommend repairing as needed.

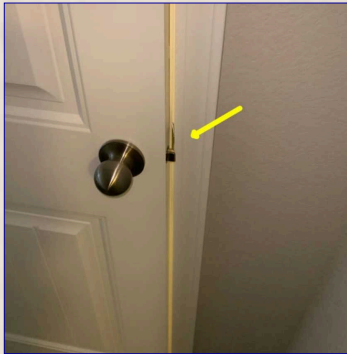
6. Door

The door does not latch. Recommend repairing as needed.

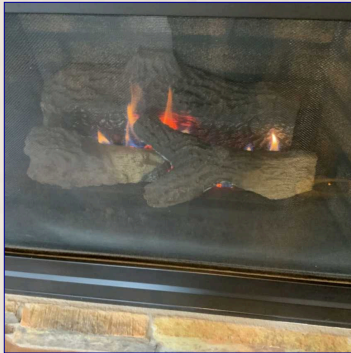
Fireplace operating.

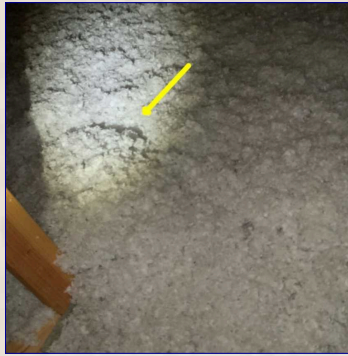
Pests are not part of the home inspection. However, there is evidence of rodent feces in the attic, which is a safety concern. Recommend a professional exterminator be consulted.

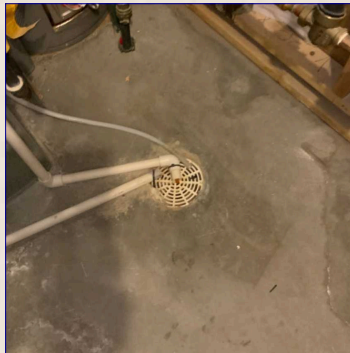
The floor drain, as seen in the basement, was not tested. Recommend pouring water into the drain periodically to help prevent sewer gases from backing up into the home.

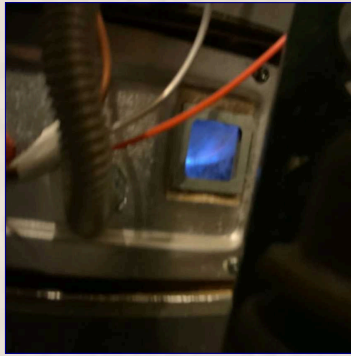
- The water heater is marked marginal based on age and potentially other issues. The actual operating life of any appliance is based on many factors that can not be predicted. Recommend regular maintenance based on the manufacturer specifications.

The water heater operating

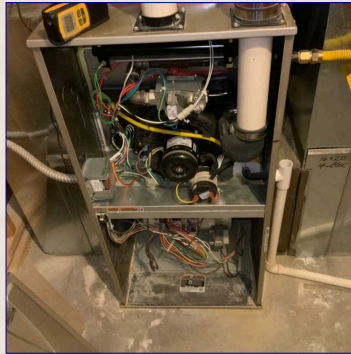
The furnace view, cover off

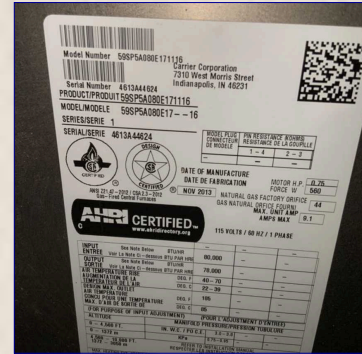
The furnace, data tag

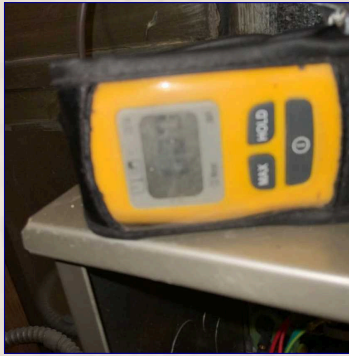
No carbon monoxide was detected. Recommend regular monitoring with proper carbon monoxide detectors. Consult a licensed HVAC technician as needed.

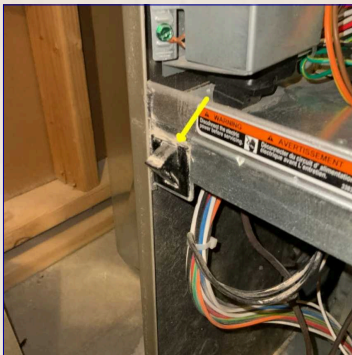
The electrical shutoff switch

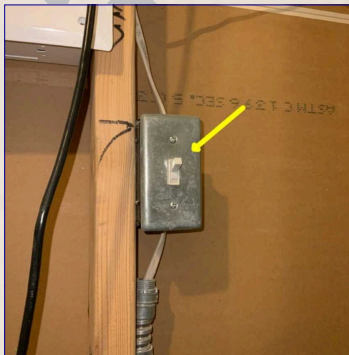
The electrical shutoff switch

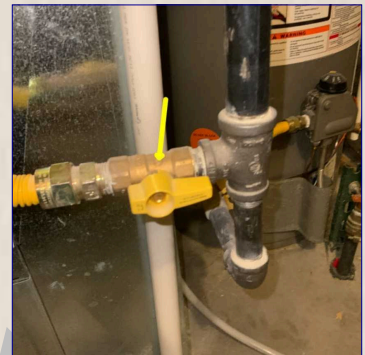
The gas shutoff

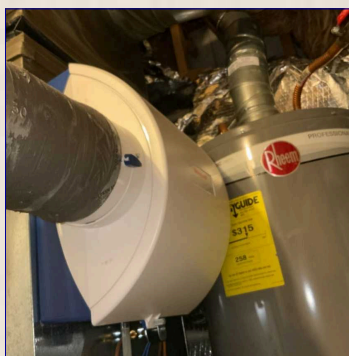
Humidifiers are not part of the home inspection. Recommend normal maintenance per the manufacturers specifications. Consult a licensed HVAC contractor as needed.

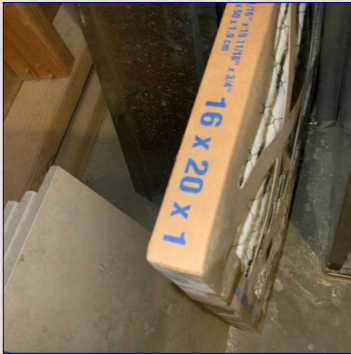
Furnace filter size.

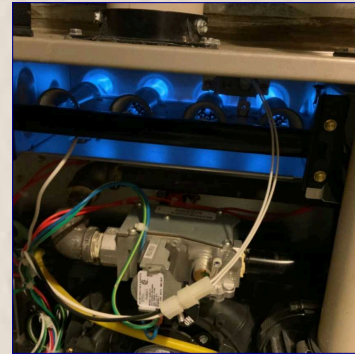
The furnace operating.

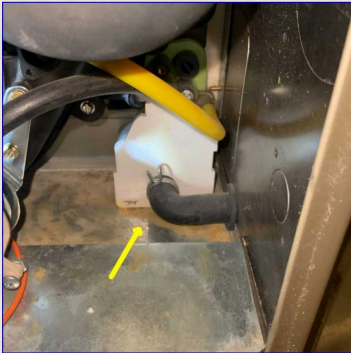
- The furnace showed signs of rust and corrosion. Recommend a professional HVAC technician repair or replace as needed.

The furnace showed signs of rust and corrosion. Recommend a professional HVAC technician repair or replace as needed.

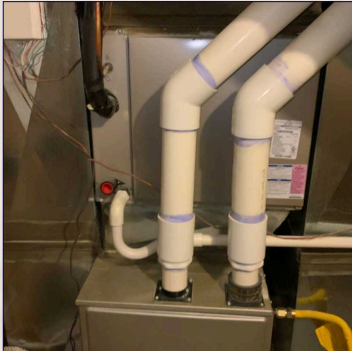
The evaporator coil cabinet

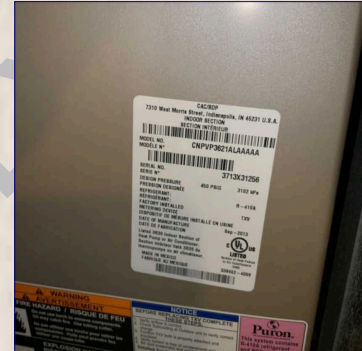
The air conditioner coils data plate

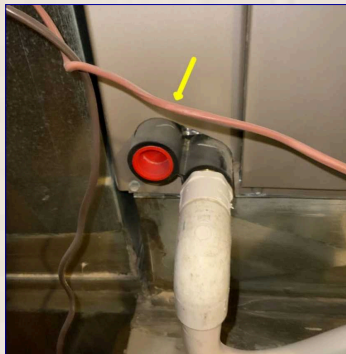
- Evaporator Coil: Not visible
- Condensate Line: To Floor Drain
- Secondary Condensate Line Present: No
- Secondary Condensate Line Needed: Yes

There is no secondary condensate protection installed on the air conditioner evaporator coil drain. This is a common practice, however, we recommend a licensed HVAC contractor install a secondary protection switch to help prevent damage to the furnace in the event that the drain becomes clogged and overflows.
